Case Study: Grace Presbyterian Church

Grace Sounds Amazing

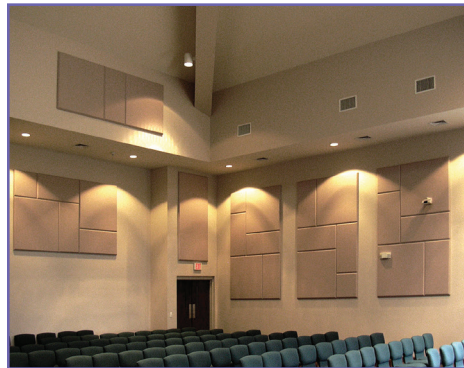
Right Sidewall And Rear Corner

For Grace, the result was 1,364 square feet of treatment by 2” thick ProPanels. The analysis process determined that this thickness addressed the low frequency issues identified in the sanctuary. The placement of these panels on upper portions of specific wall surfaces and areas of the ceiling was designed to enhance speech intelligibility and promote an evenly distributed worship presentation.

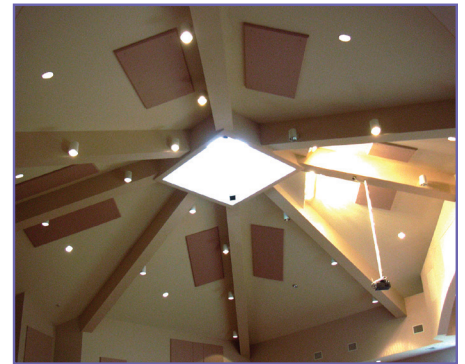
The shape of Grace’s sanctuary is somewhat unique in that it’s octagonal. Because of that, the eight-sided ceiling came to a mischievous peak. Sound from the band was hitting all eight sides of the ceiling and effectively bouncing around the sanctuary, echoing through the chamber. This wasn’t a problem when the service consisted solely of a chorus and organ because reflections may actually enhance those types of performances. When drums, bass guitars and amps are added, it creates a problem.

Octagonal Ceiling

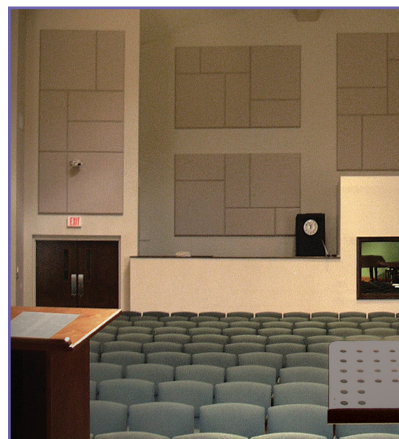
Rear Wall From Stage

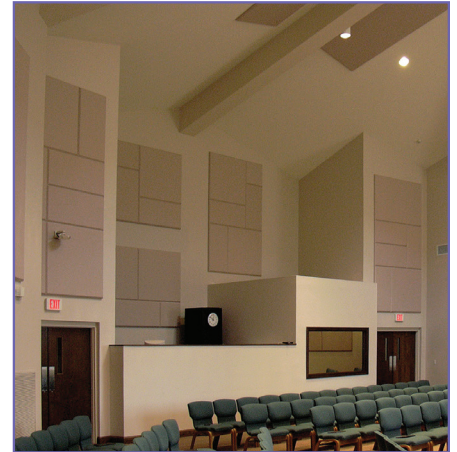
Propanel Layout On Rear Wall

According to Auralex, a directional fabric is where art meets physics – and where Auralex truly differentiates itself. “With us, the extra step is the next step. So to ensure that Grace received the look they were hoping to achieve, Auralex designed a geometric pattern that would accent the clean look created by the directional fabric. If this had been left to chance, the variations in the fabric could have created a shadow affect – like lines when
